**SOUTHWESTERN COASTAL BASIN
GREENWICH, CONNECTICUT**

**AMERICAN CAN COMPANY DAM
CT 00047**

**PHASE 1 INSPECTION REPORT
NATIONAL DAM INSPECTION PROGRAM**

FEBRUARY, 1980

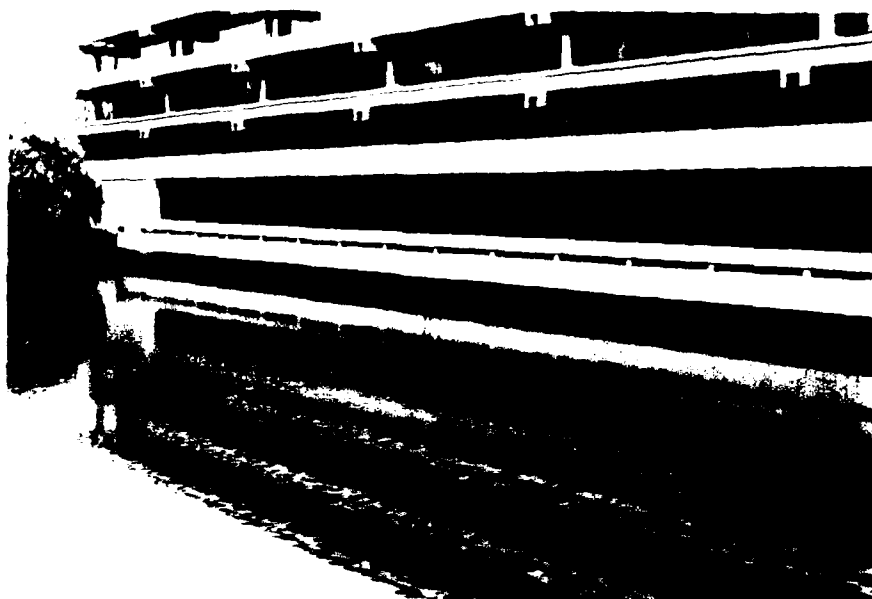
- b. **Dam:** The north wall of the parking garage retains the earth and lake for 5 levels below grade. There was no seepage observed at any place on the face of this wall. The general condition of this wall was very good. No evidence of any settlement or movement was observed (Photos C-1, C-2).

C-1 NORTH FACE OF BUILDING - LOOKING AT EAST ADJUTMENT

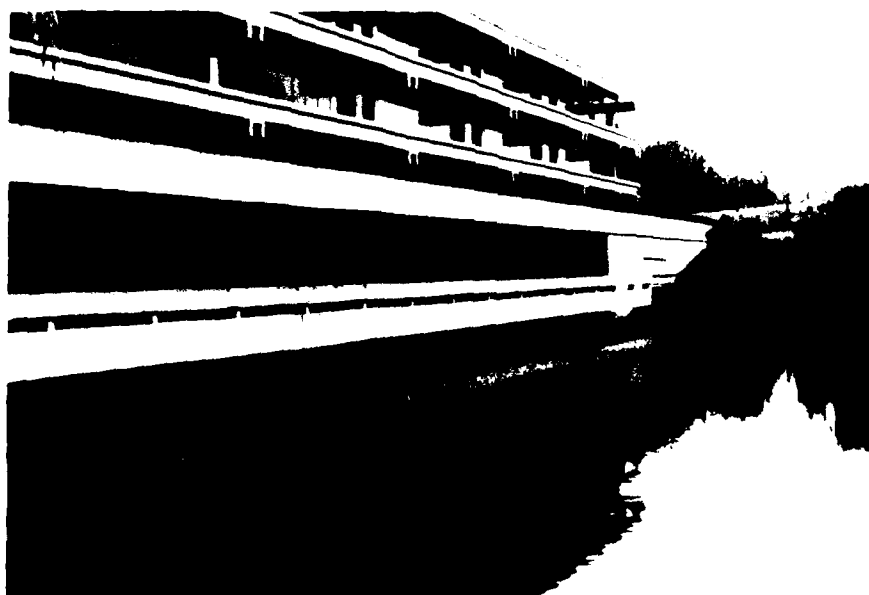
C-2 NORTH FACE OF BUILDING - LOOKING AT WEST ADJUTMENT

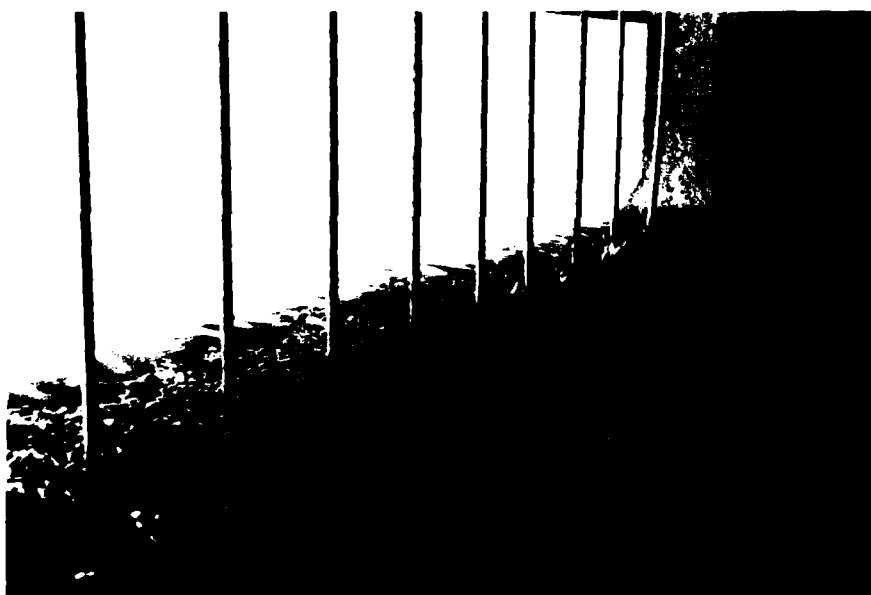
C-4 OVERFLOW WEIR - LOOKING FROM INTERIOR OF BUILDING

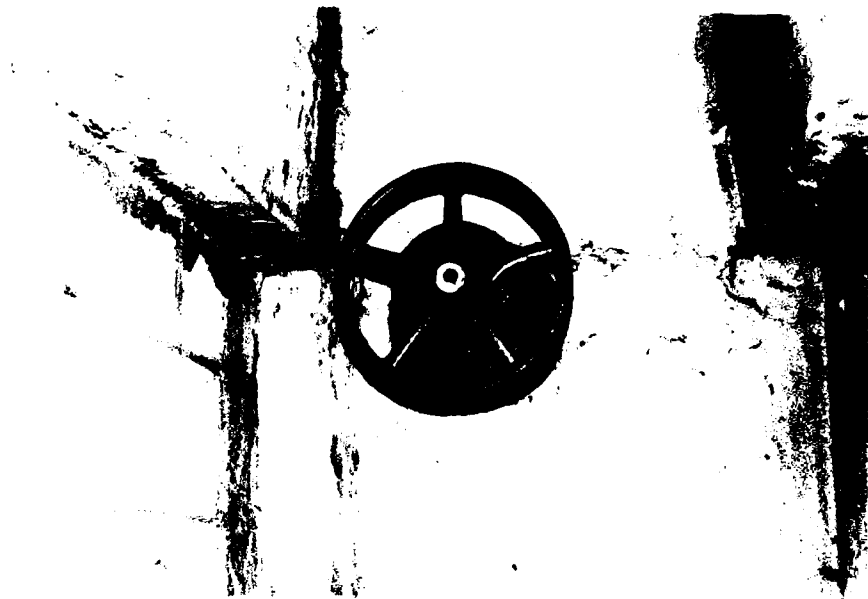
- c. **Appurtenant Structures:** The overflow weir for this pond drains into a 3' x 8' vertical chase, outletting to a 48 inch RCP, which goes under the building and drains into the swamp area on the south side of the building. The weir was in good condition and seemed to be functioning very well. The maximum depth of water on the weir that anyone could recall was approximately 3 inches (Photos C-3, C-4). A 12 inch drain, controlled by a valve in the building (Photo C-5) also extends from the pond to the chase.

C-5 GATE VALVE CONTROL FOR 12 INCH DRAIN
